White paper

Fiber Optic Connectors

Why Expanded Beam types are essential in military and other harsh environment applications

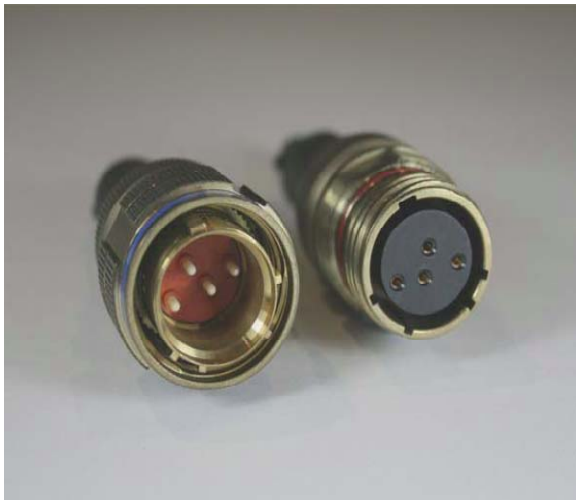
Typical Butt-Joint Plug and Receptacle Connectors

The plug connector ferrules are fully exposed and easily contaminated or damaged when un-mated.

The ferrules and alignment sleeves in the receptacle connector are recessed deep in the connector face, creating a dirt trap and making cleaning difficult.

Connector disassembly is required to properly clean the ferrules and alignment sleeves.

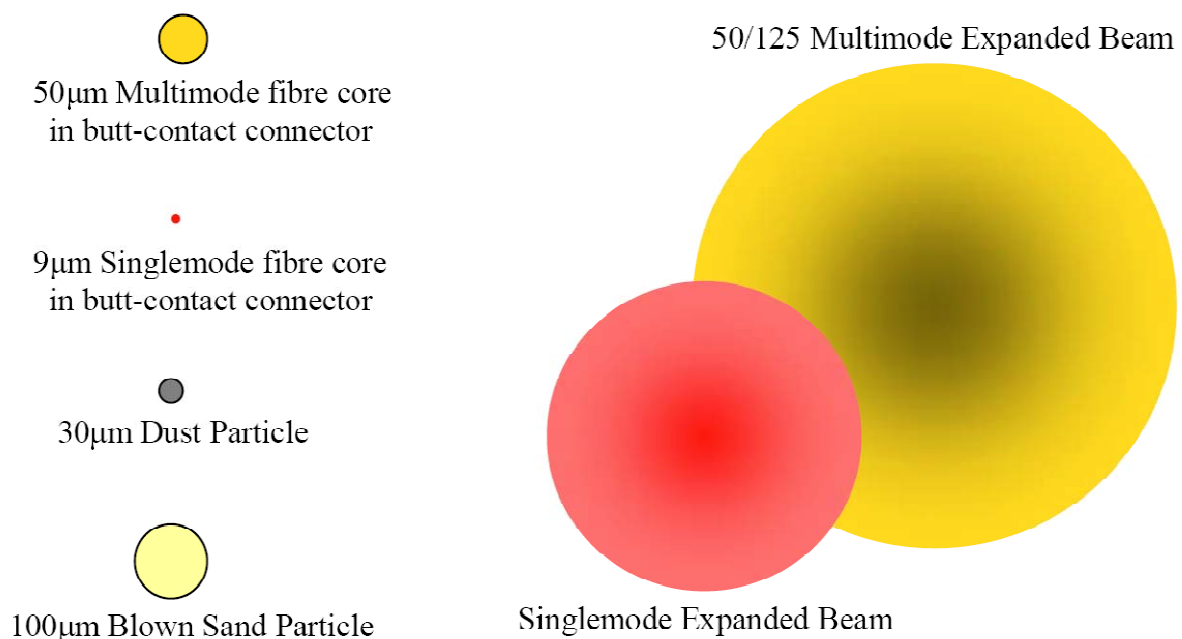
The following is a scale representation of butt-joint and expanded beam diameters showing typical contaminant sizes:

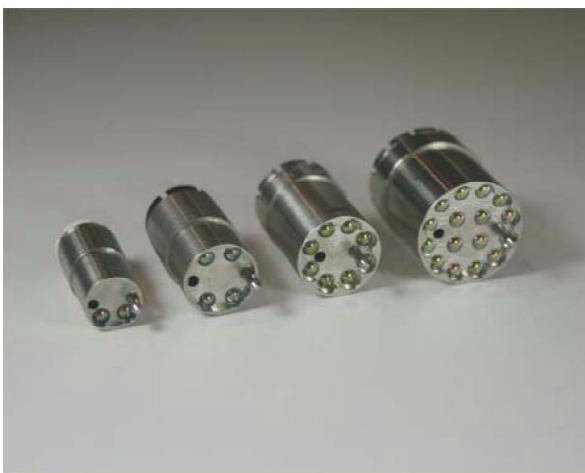
Various Expanded Beam Inserts

Multi-channel expanded beam connector inserts have been developed to offer a practical method of packaging the expanded beam concept. Typical expanded beam inserts comprise a stainless metal housing containing 1 to 16 spherical lenses (optical channels).

The front face of the expanded beam insert has a mating surface, an alignment pin and socket and one or more spherical lenses which are epoxy sealed. The lenses have an extremely hard anti-reflection coating. The Fibreco expanded beam insert has been carefully designed to avoid "dirt traps" and the largely flat front surfaces facilitate easy cleaning.

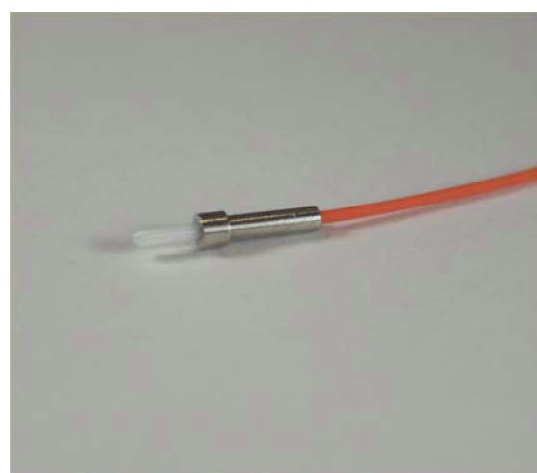
Expanded Beam Termination Ferrule

Fibreco expanded beam inserts are easily terminated with standard fiber optic termination tools and equipment. Termination ferrules, based on standard LC connector technology (1,25mm diameter) are terminated onto optical fiber cable using the industry standard epoxy and polish technique. The termination ferrules are then simply inserted into the rear of the expanded beam insert and fixed in place with a retainer.

The termination ferrule can easily be removed from the expanded beam insert for connector re-use or repair. Importantly, should the expanded beam insert be damaged in service the connector can be repaired by replacing the expanded beam insert without the need to re-terminate the termination ferrules.

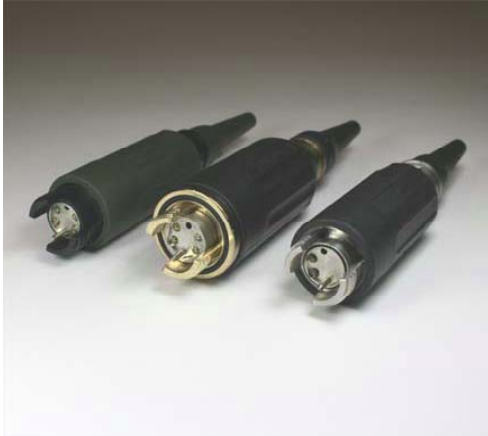
Hermaphroditic type expanded beam connectors have been designed specifically for external harsh environment applications and are widely used in military tactical communications, outside broadcast, mining and many other industrial applications.

Cable assemblies with hermaphroditic connectors can be easily daisy-chained and there is no requirement for male / female adaptors.

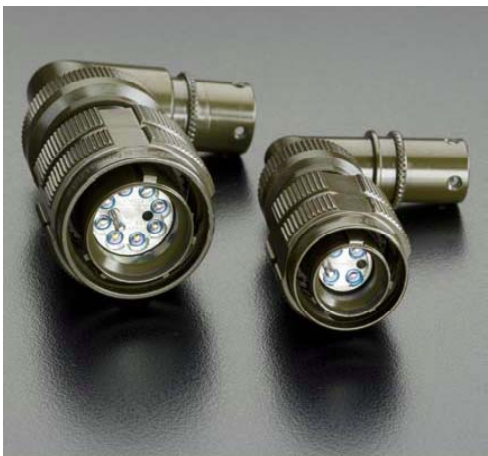
MIL-C-38999 Series III expanded beam connectors are used in electronic equipment interface applications on military vehicles, aircraft and ships.

Size 11, 13, 15 and 17 connector shells are offered with 1 to 16 optical channels.

The connector features the generic MIL-C-38999 Series III tri-start thread and one turn self-locking, anti-vibration coupling mechanism.

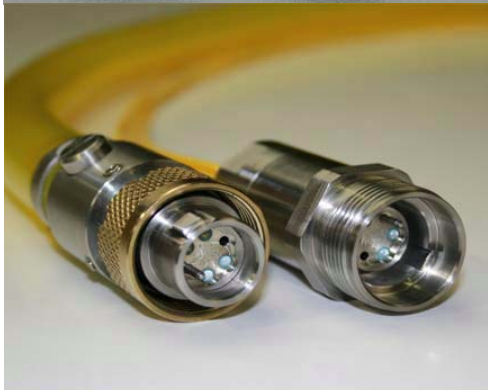
Dry-mate sub-sea connector with four channel expanded beam insert.

Stainless Steel and Silicon Bronze shells with a depth rating of 3.000 meters for ROV applications.

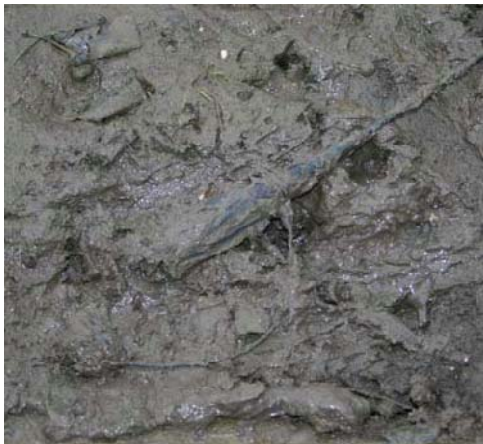
1. Plug connector immersed in mud. The connector is fully sealed even without the dust cap fitted.

The following demonstrates the ability of the Junior military tactical connector to resist mud immersion and be easily cleaned and returned to service with no detrimental effect on its optical performance:

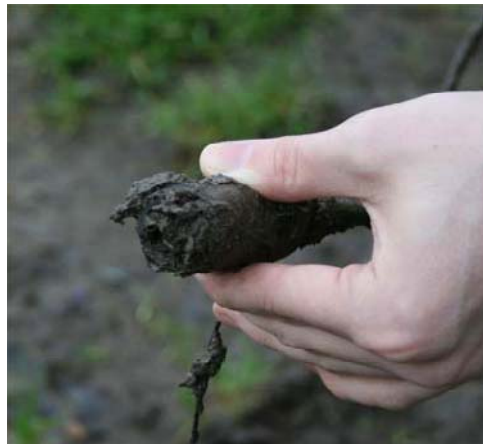
2. The mud will not cause damage to the expanded beam insert. A butt-contact connector would almost certainly already be destroyed in this state

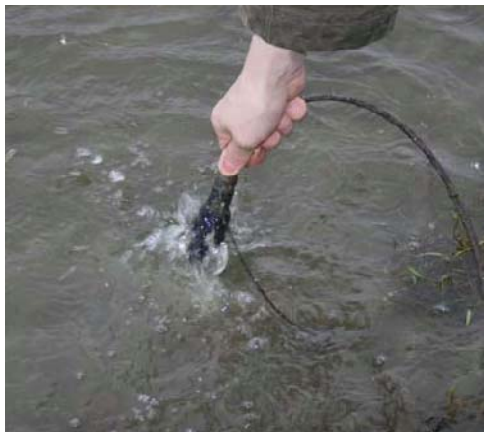
3. Initial cleaning to remove mud and debris from the connector face can be done by rinsing in water. A hose, bucket of water, stream or muddy puddle will do.

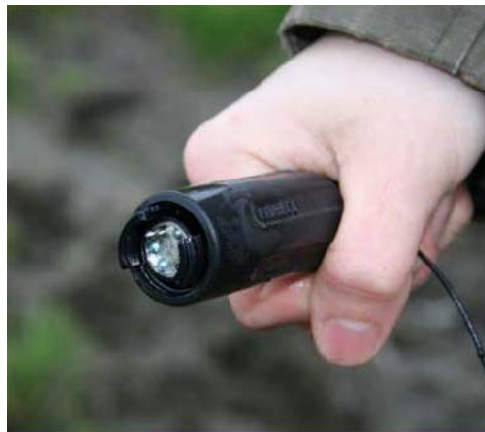
4. Connector end-face is clean after rinsing.

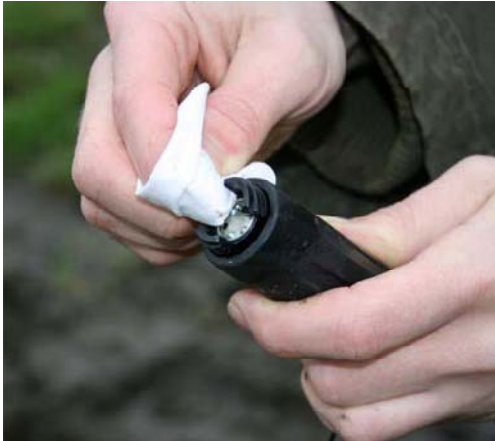
5. The insert face is dried and wiped clean. Ideally a clean cloth or tissue is used but if these are not available the bottom of your coat will suffice.

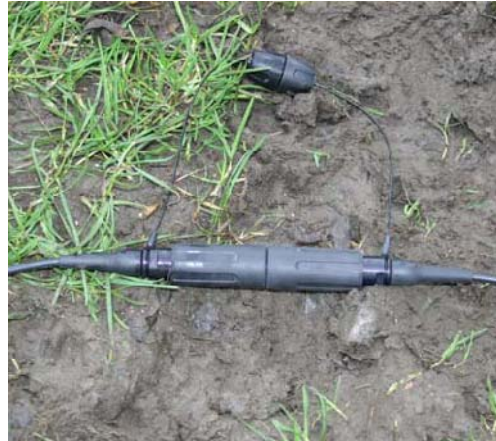
6. Connectors plugged and ready for use.

- The whole cleaning cycle was completed in under 5 minutes.
- No damage to the insert surfaces or lenses will occur.
- Insertion loss was measured between $-0,90\text{dB}$ to $-1,15\text{dB}$ (9/125 4 channels) with an OTDR (Optical Time Domain Reflectometer).
